“Commercial Demonstration of the Manufactured Aggregate
Processing Technology Utilizing Spray Dryer Ash”

Final Technical Report

DOE Award No: DE-FC26-02NT41421

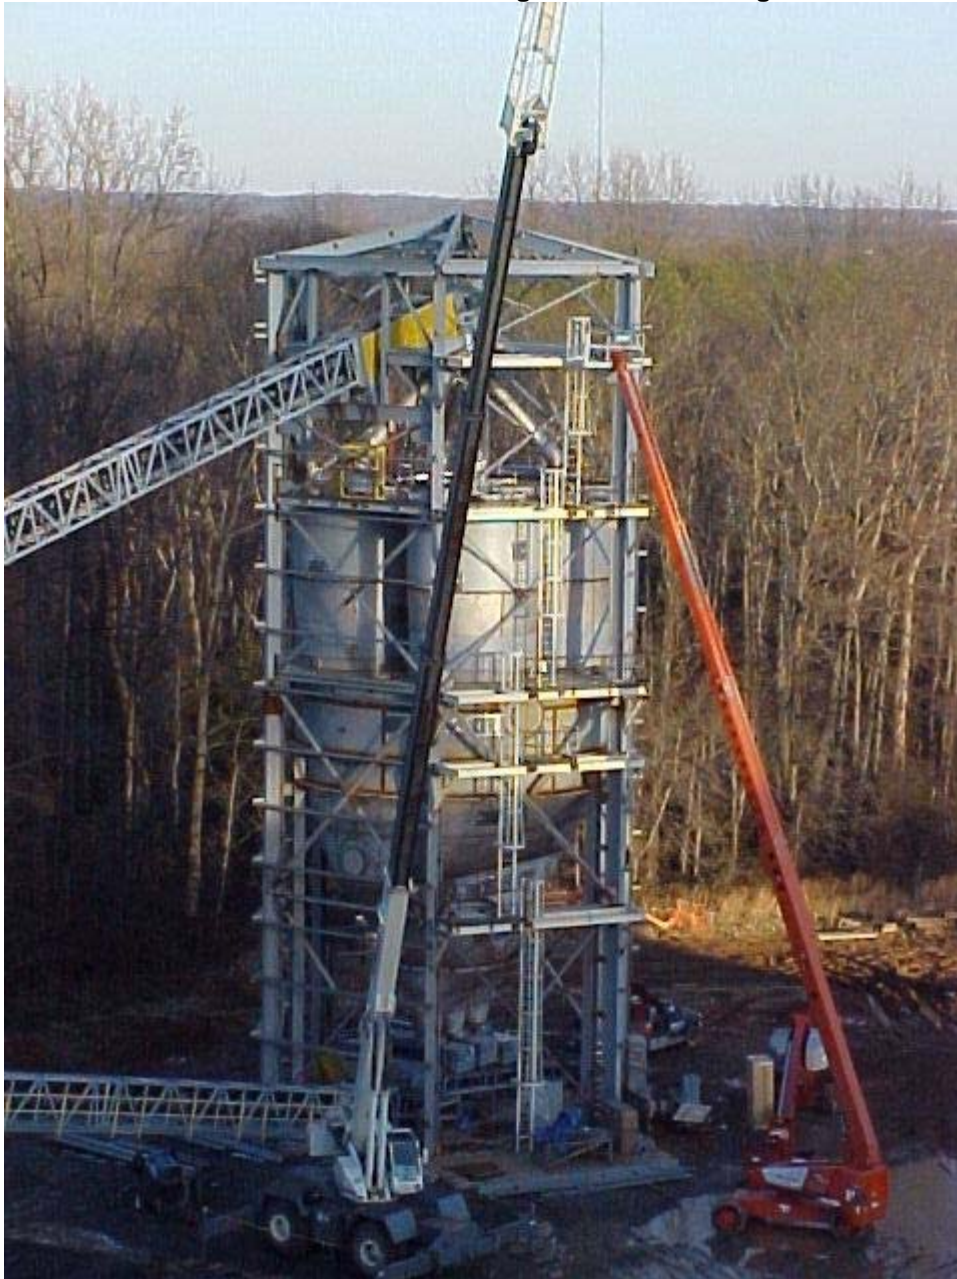
Demonstration Plant Construction Curing Vessel and Curing Vessel Building

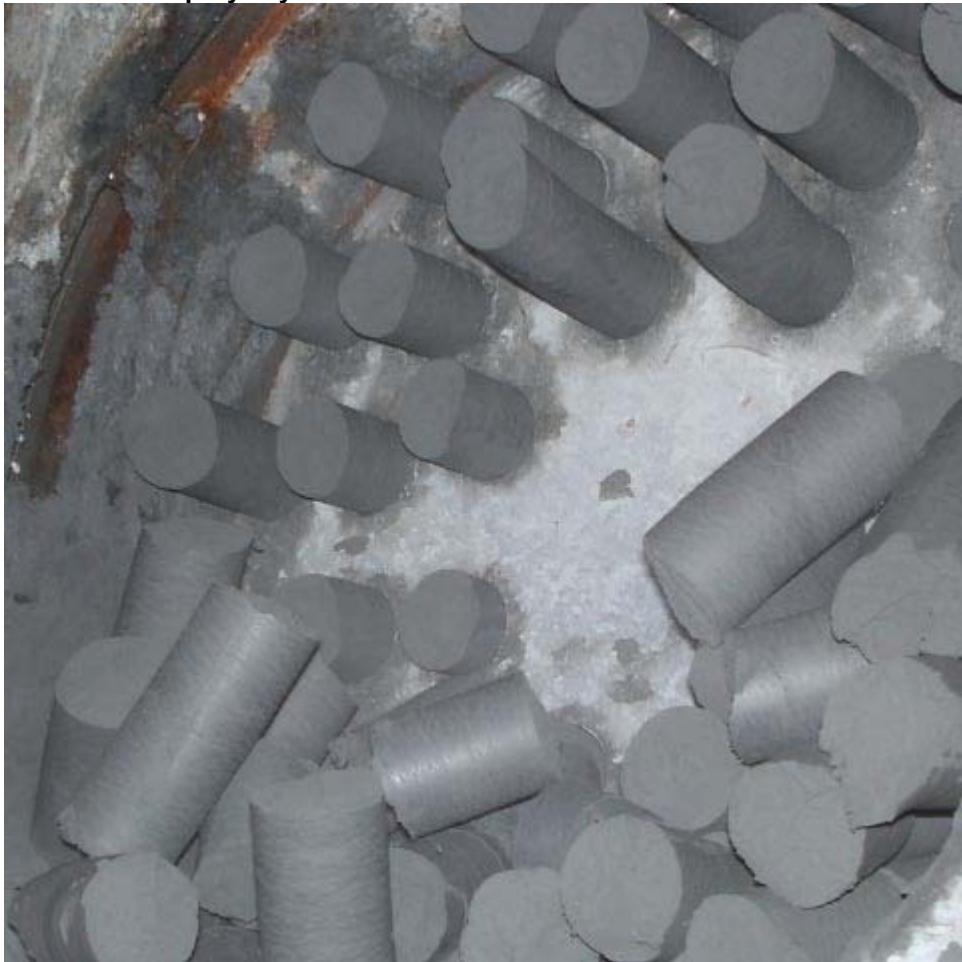
Extrusion of Spray Dryer Ash at Demonstration Plant
